Submission: Hanson Expansion Application - DA378-18 and DA462-18 2

This is a submission regarding the application by Hanson Construction Materials Pty Ltd (Hanson) for an expansion of their Red Hill Quarry. In principle we do not have an objection to the application, however we would like to see some conditions and actions taken prior to it is granted.

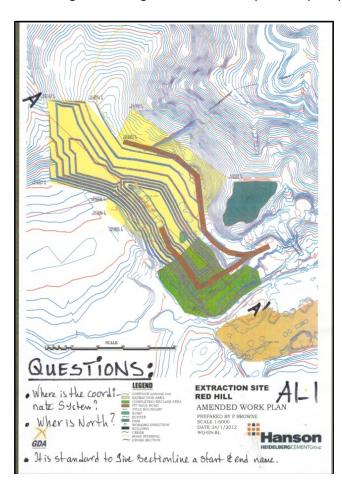
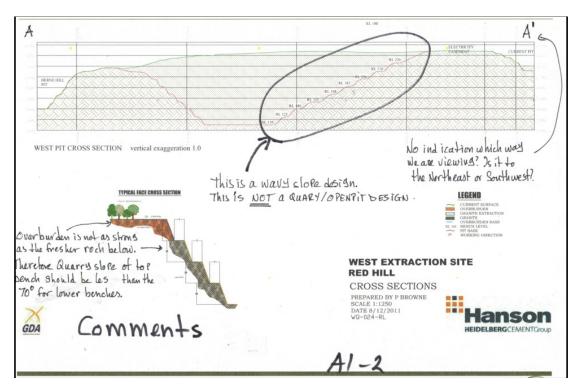
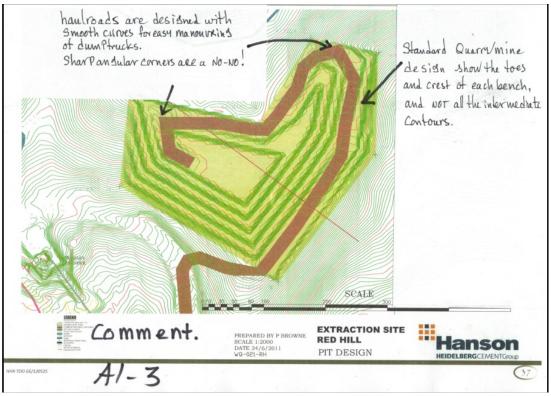
Images A1-1 to A1-3 are figures from the reports with comments to illustrate the short comings of these diagrams. Image A1-4 is an example of a quarry design.

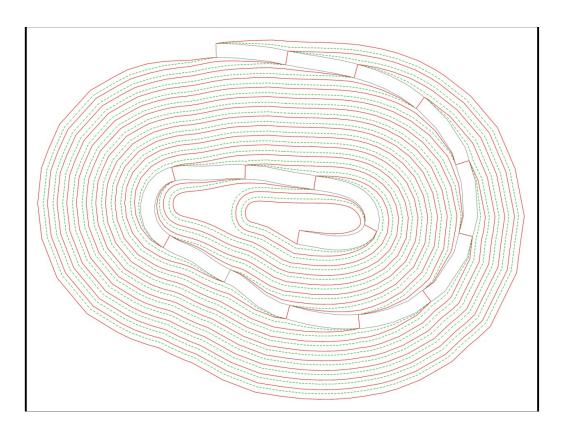
A1-4: An example of a proper quarry / openpit design including a haulroad produced with Micromine mining software.

The red lines are the "crest" or top of each bench and the dotted green lines the "toe" of each bench.
